ADAS IdentiScan Report

VIN #	SALFR2BN1BH230860
Year	2011
Make	Land Rover
Model	LR2
Trim Level	Base
Vehicle Type	Sport Utility Vehicle
Paint Code	867
Paint Name	Fuji White
Interior Trim	(coming soon)

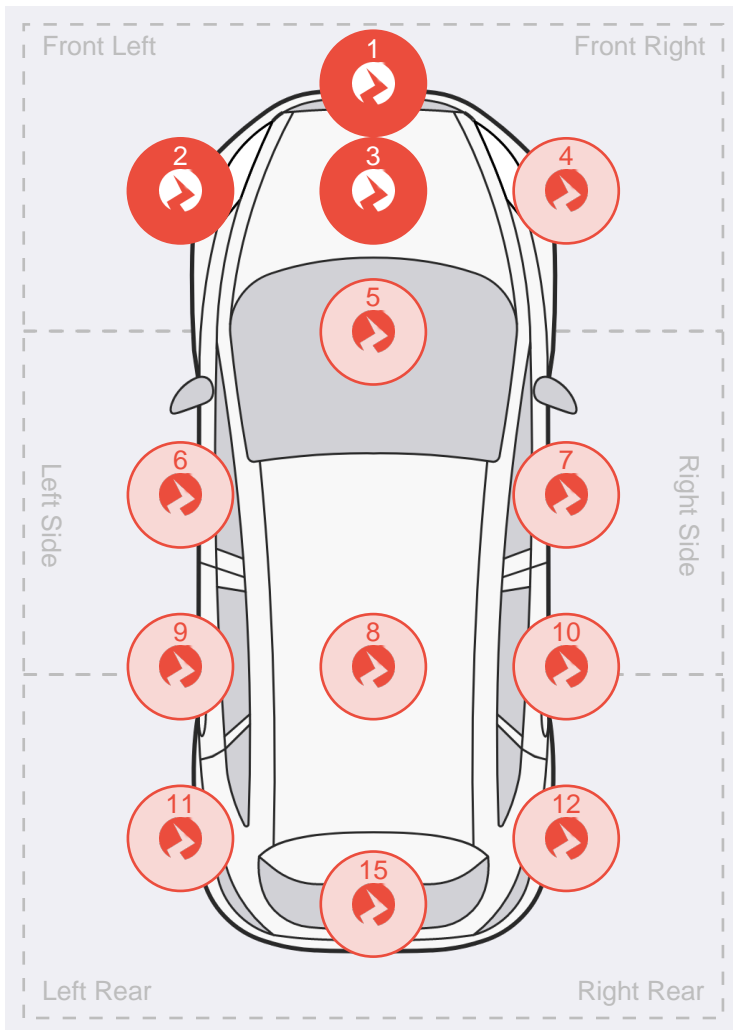
Damage Area Map

Is there any wheel damage or suspension work to be performed?	Yes
Has there been any suspension modifications (lift, lowering, or leveling kits) (or) have the wheels been modified from the original factory specs?	No
Are you going to drop the headliner?	No
Did any restraint systems deploy? (belts, bags, buckles, etc...)	Yes
Are any dash lights on?	Yes
